**XR6, XR10, XR20, and XR40 Update**

**November 19, 1998**

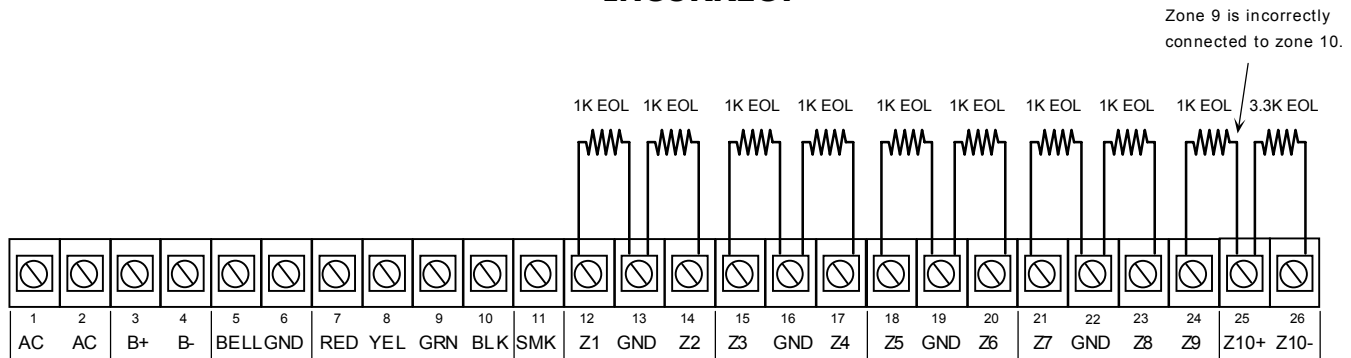
**INCORRECT**

The end-of-line resistor for zone 9 must not be accidentally connected to the positive terminal of zone 10 as shown below.

When zone 9 is incorrectly connected to zone 10, a false alarm may occur on zone 2 of the panel when the panel picks up the telephone line to communicate to the receiver.
